**A MARINE & SHORELINE ENVIRONMENTAL IMPACT ASSESSMENT REPORT FOR PROPOSED
NATIONAL WORKS AGENCY SHORELINE STABILIZATION WORKS – PALISADES, KINGSTON.**

May 2007

**PETER WILSON-KELLY MPhil.
RICHARD KELLY MSc.**

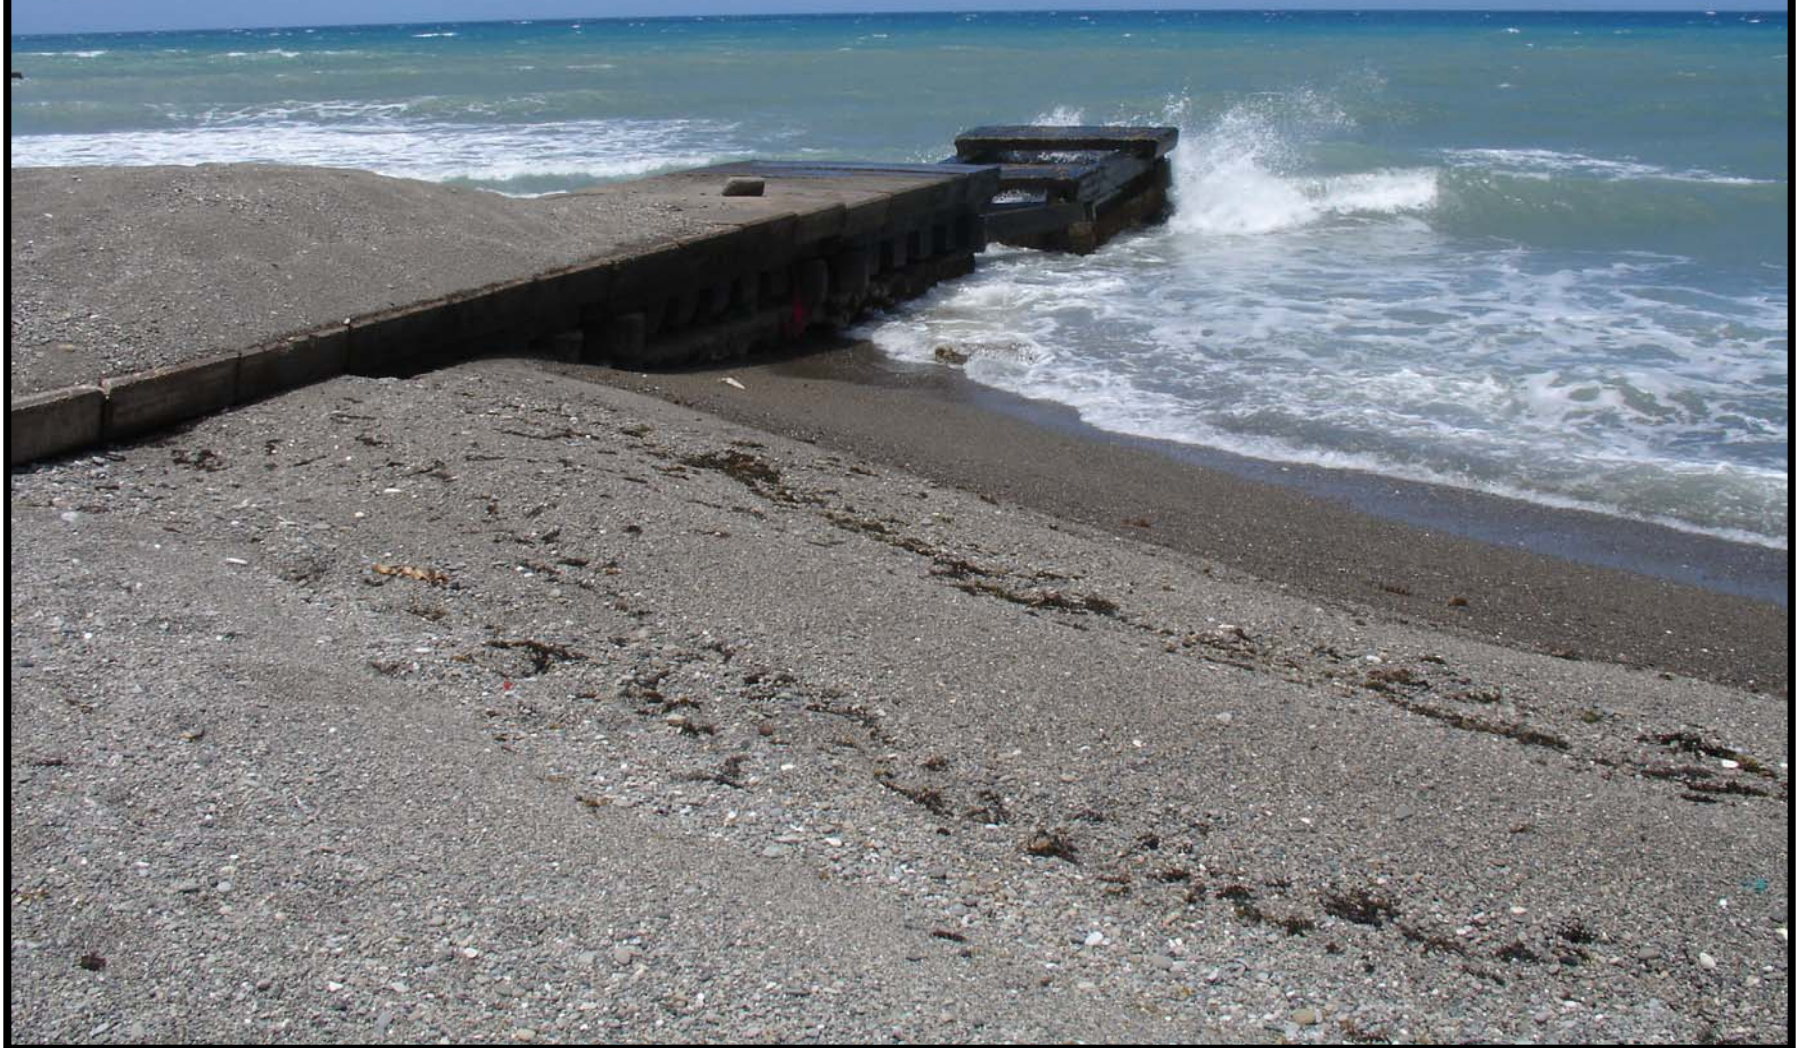
FIGURE 1B Ground-based Photo of the Sidney Makepeace Wood designed groynes at Palisadoes in Kingston (Image 2007)

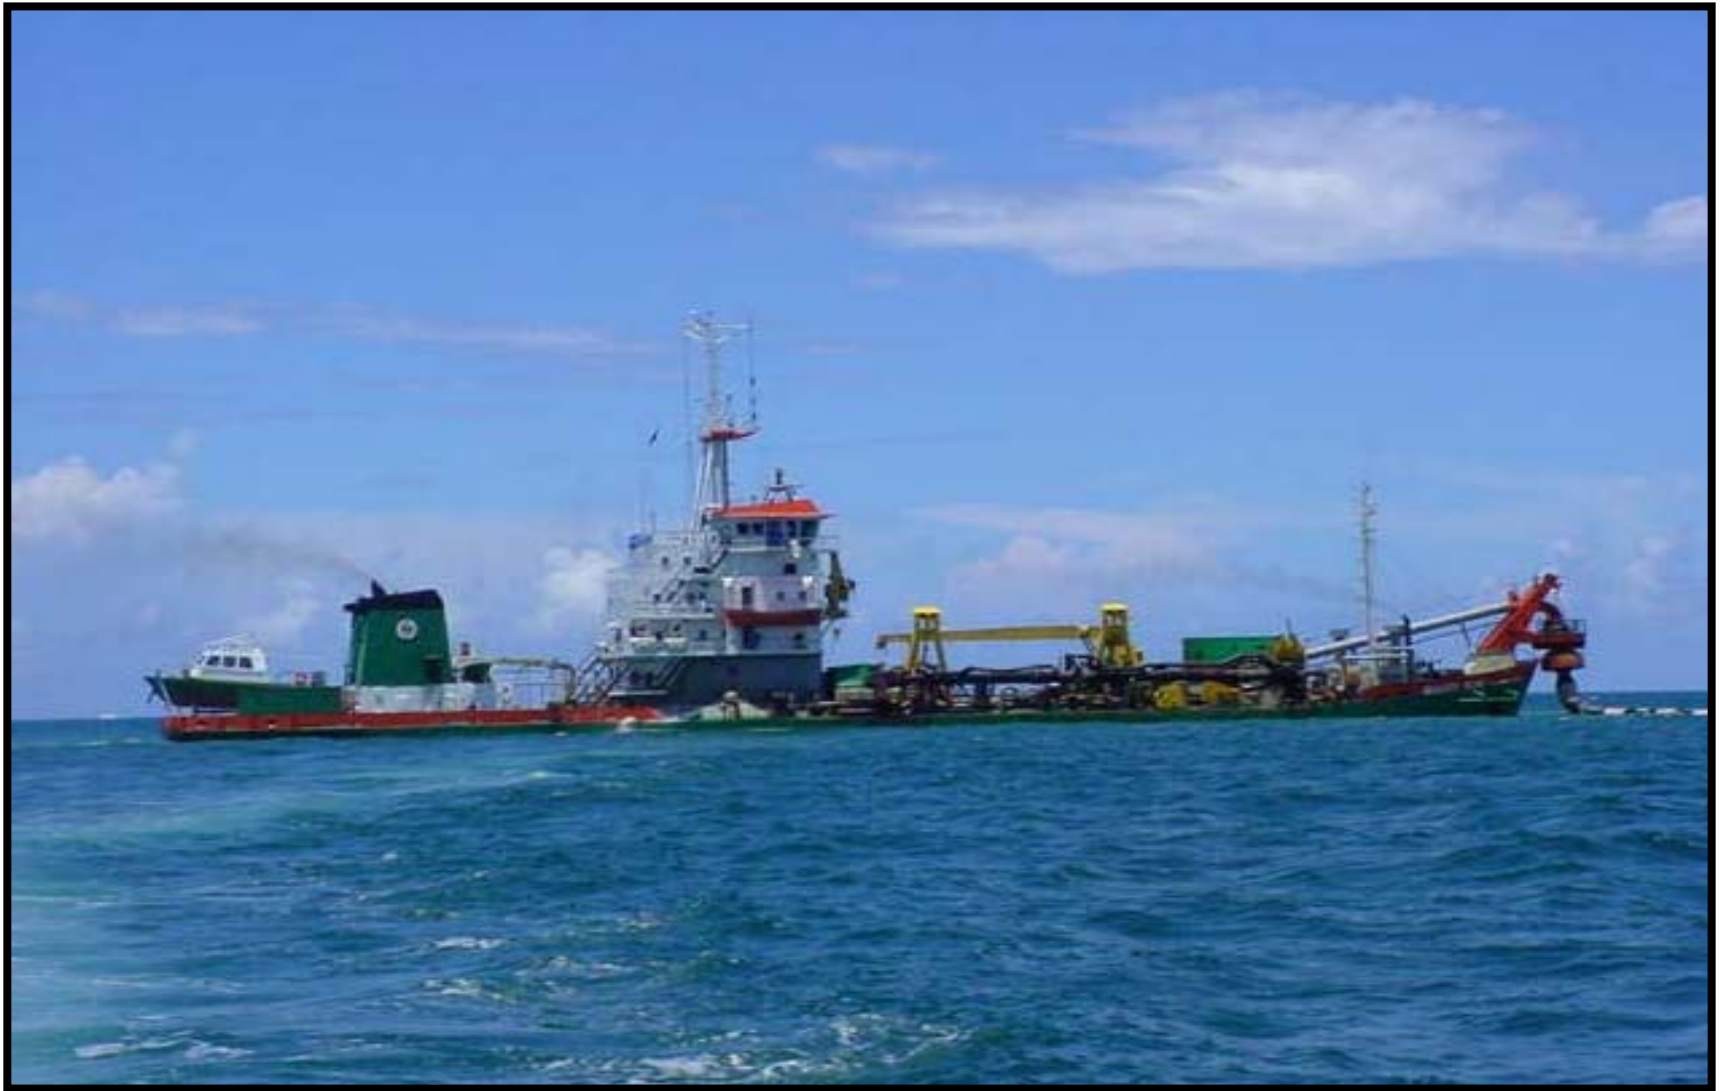
**FIGURE 3D Picture of Proposed Trailing
Suction Hopper Dredge**

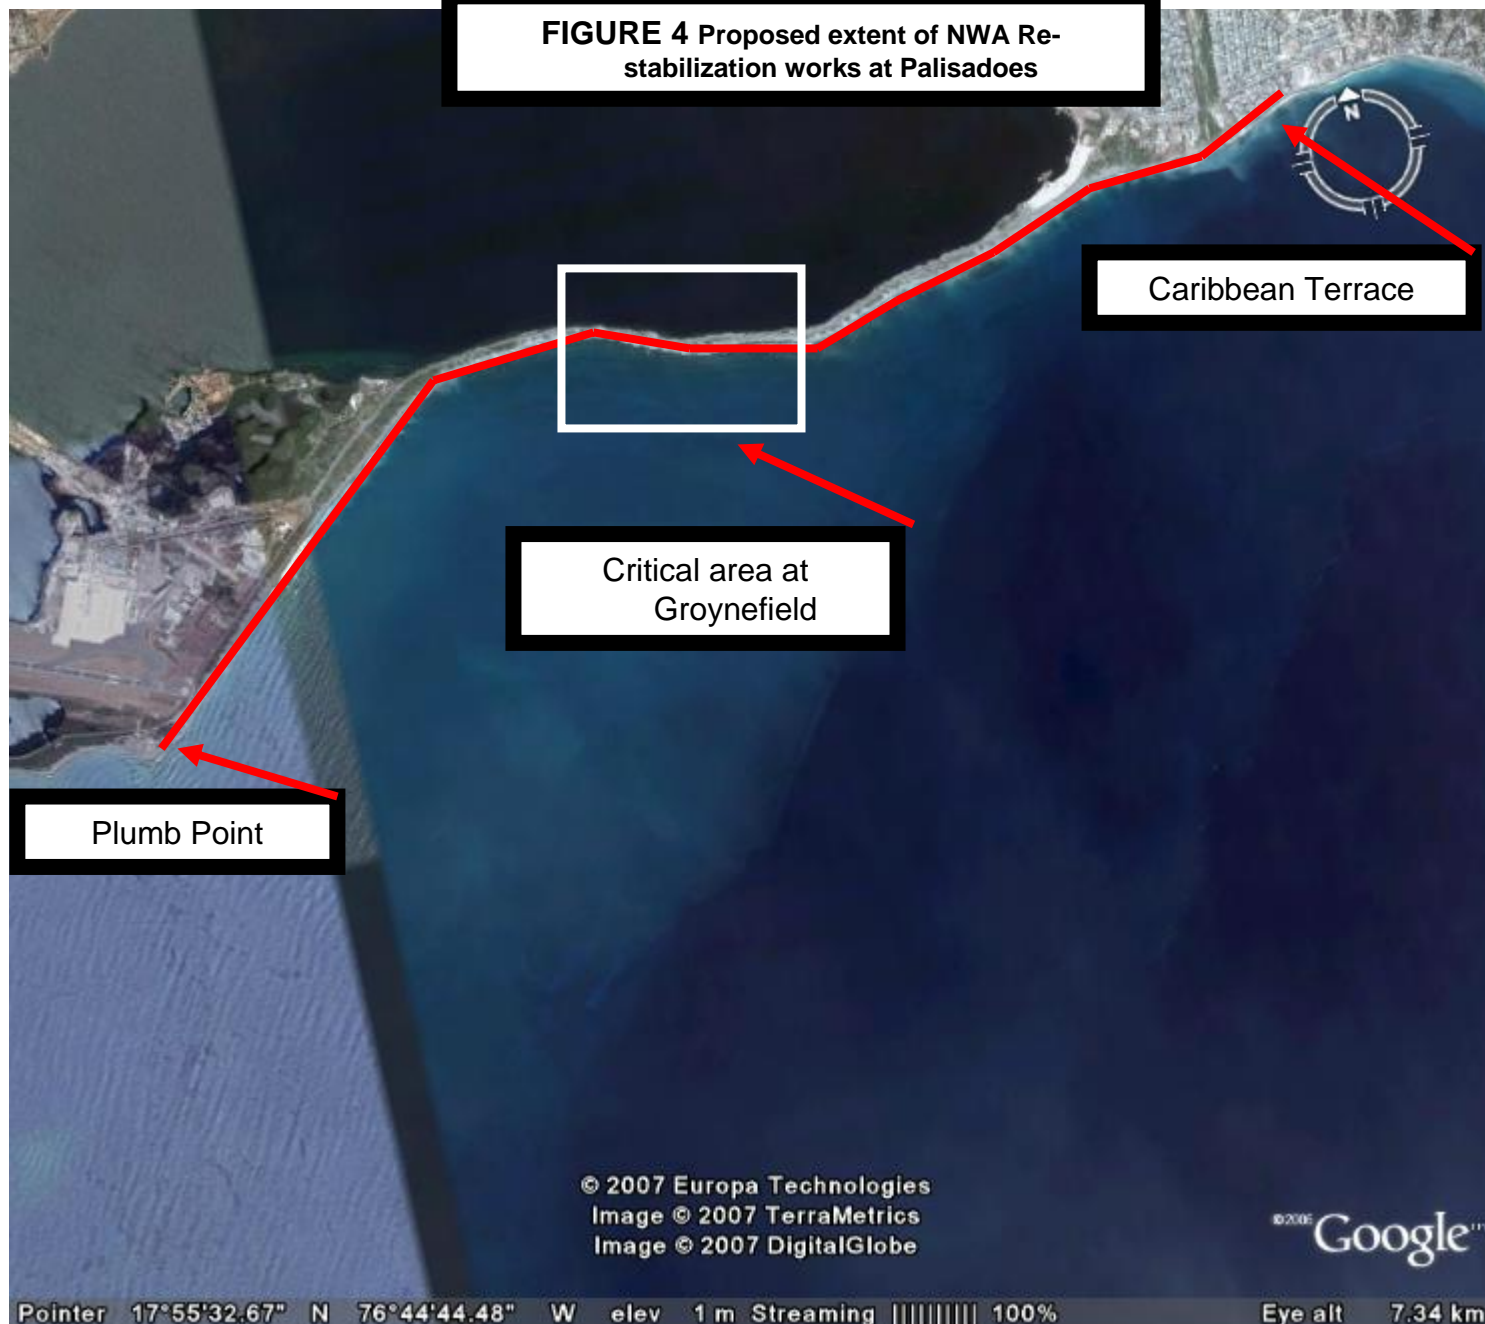
FIGURE 4 Proposed extent of NWA Re-stabilization works at Palisadoes

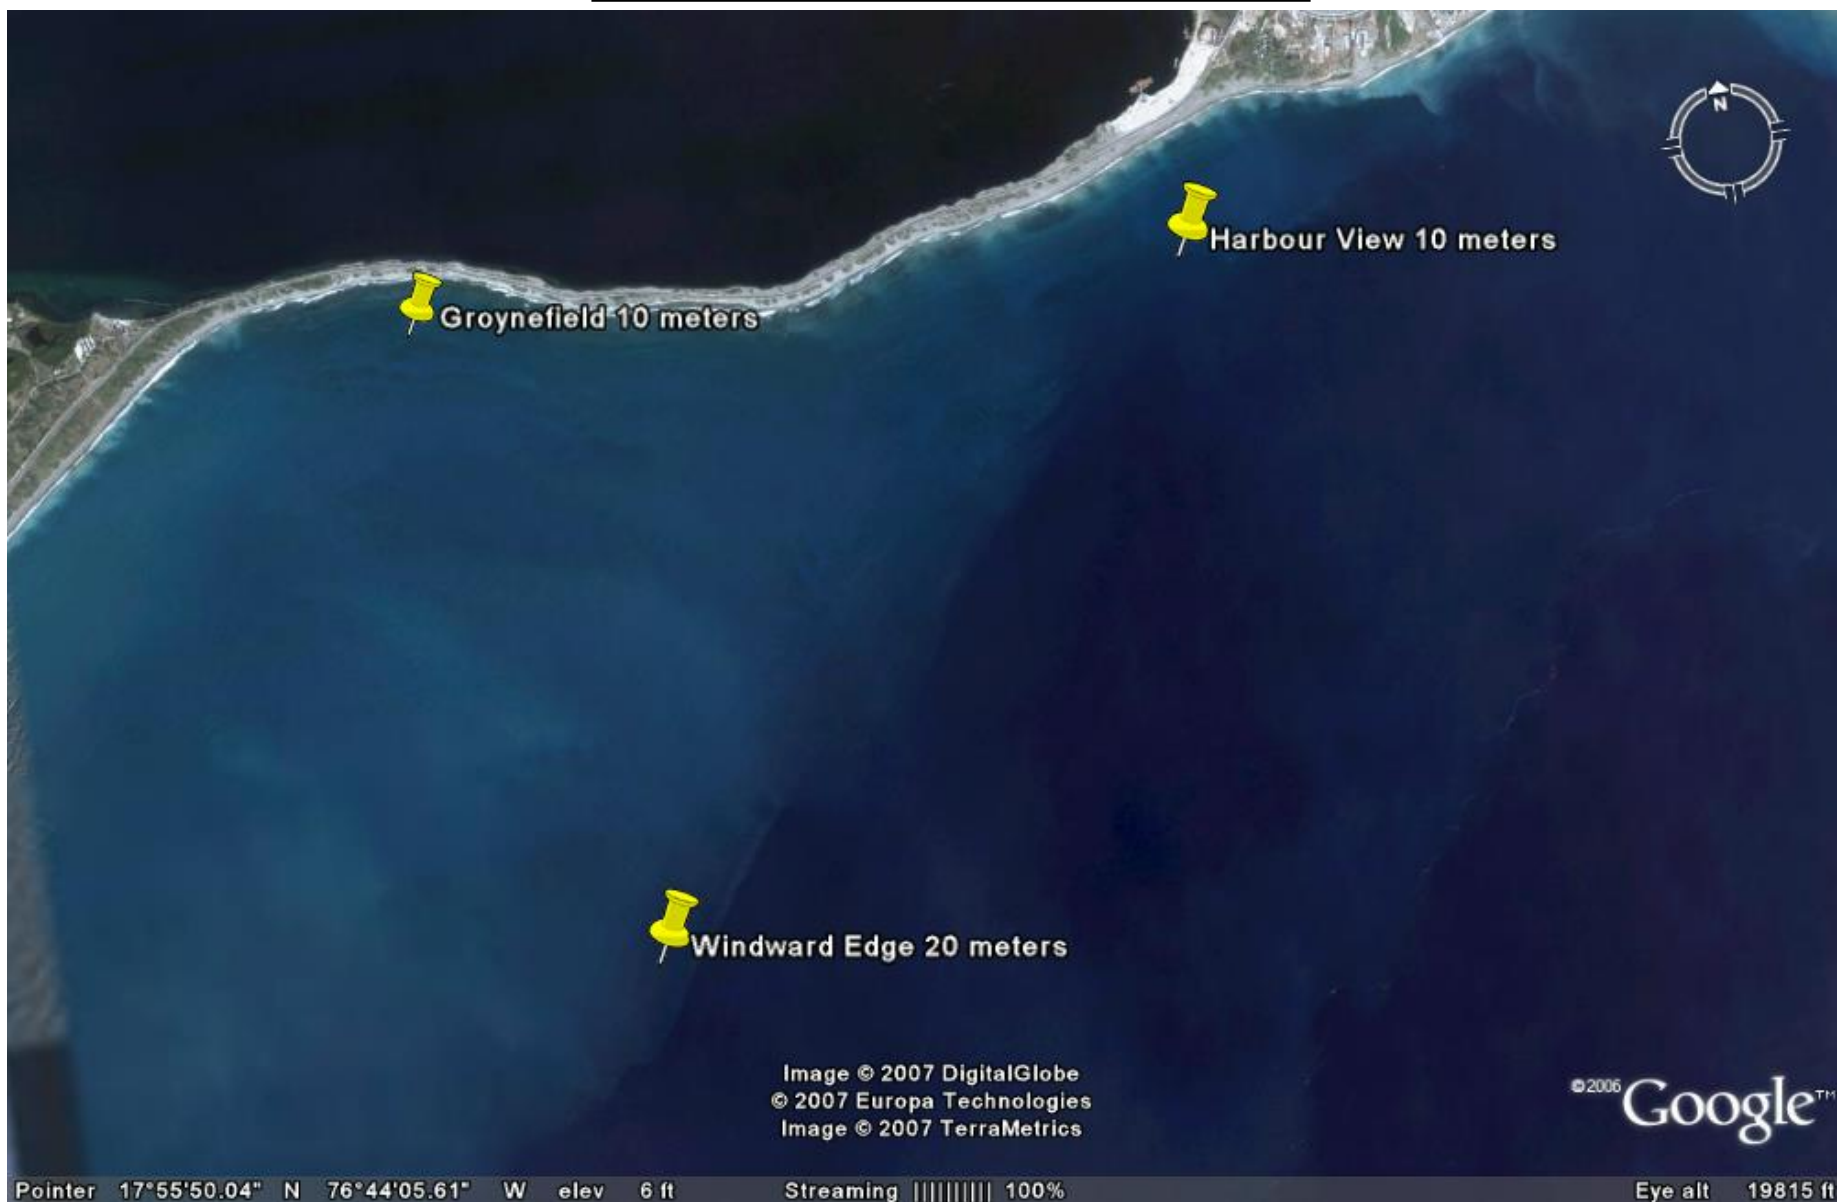
**FIGURE 8 Marine Groundtruthing Sites at
Palisadoes Re-nourishment area**

Types of fish observed at the ground truthing sites outlined on **Figure 8 –Appendix 1** and estimates of their numbers were obtained using the Transect and roving fish count methods defined for the Atlantic Gulf Rapid Reef Assessment (AGRRA) protocol ²⁰.

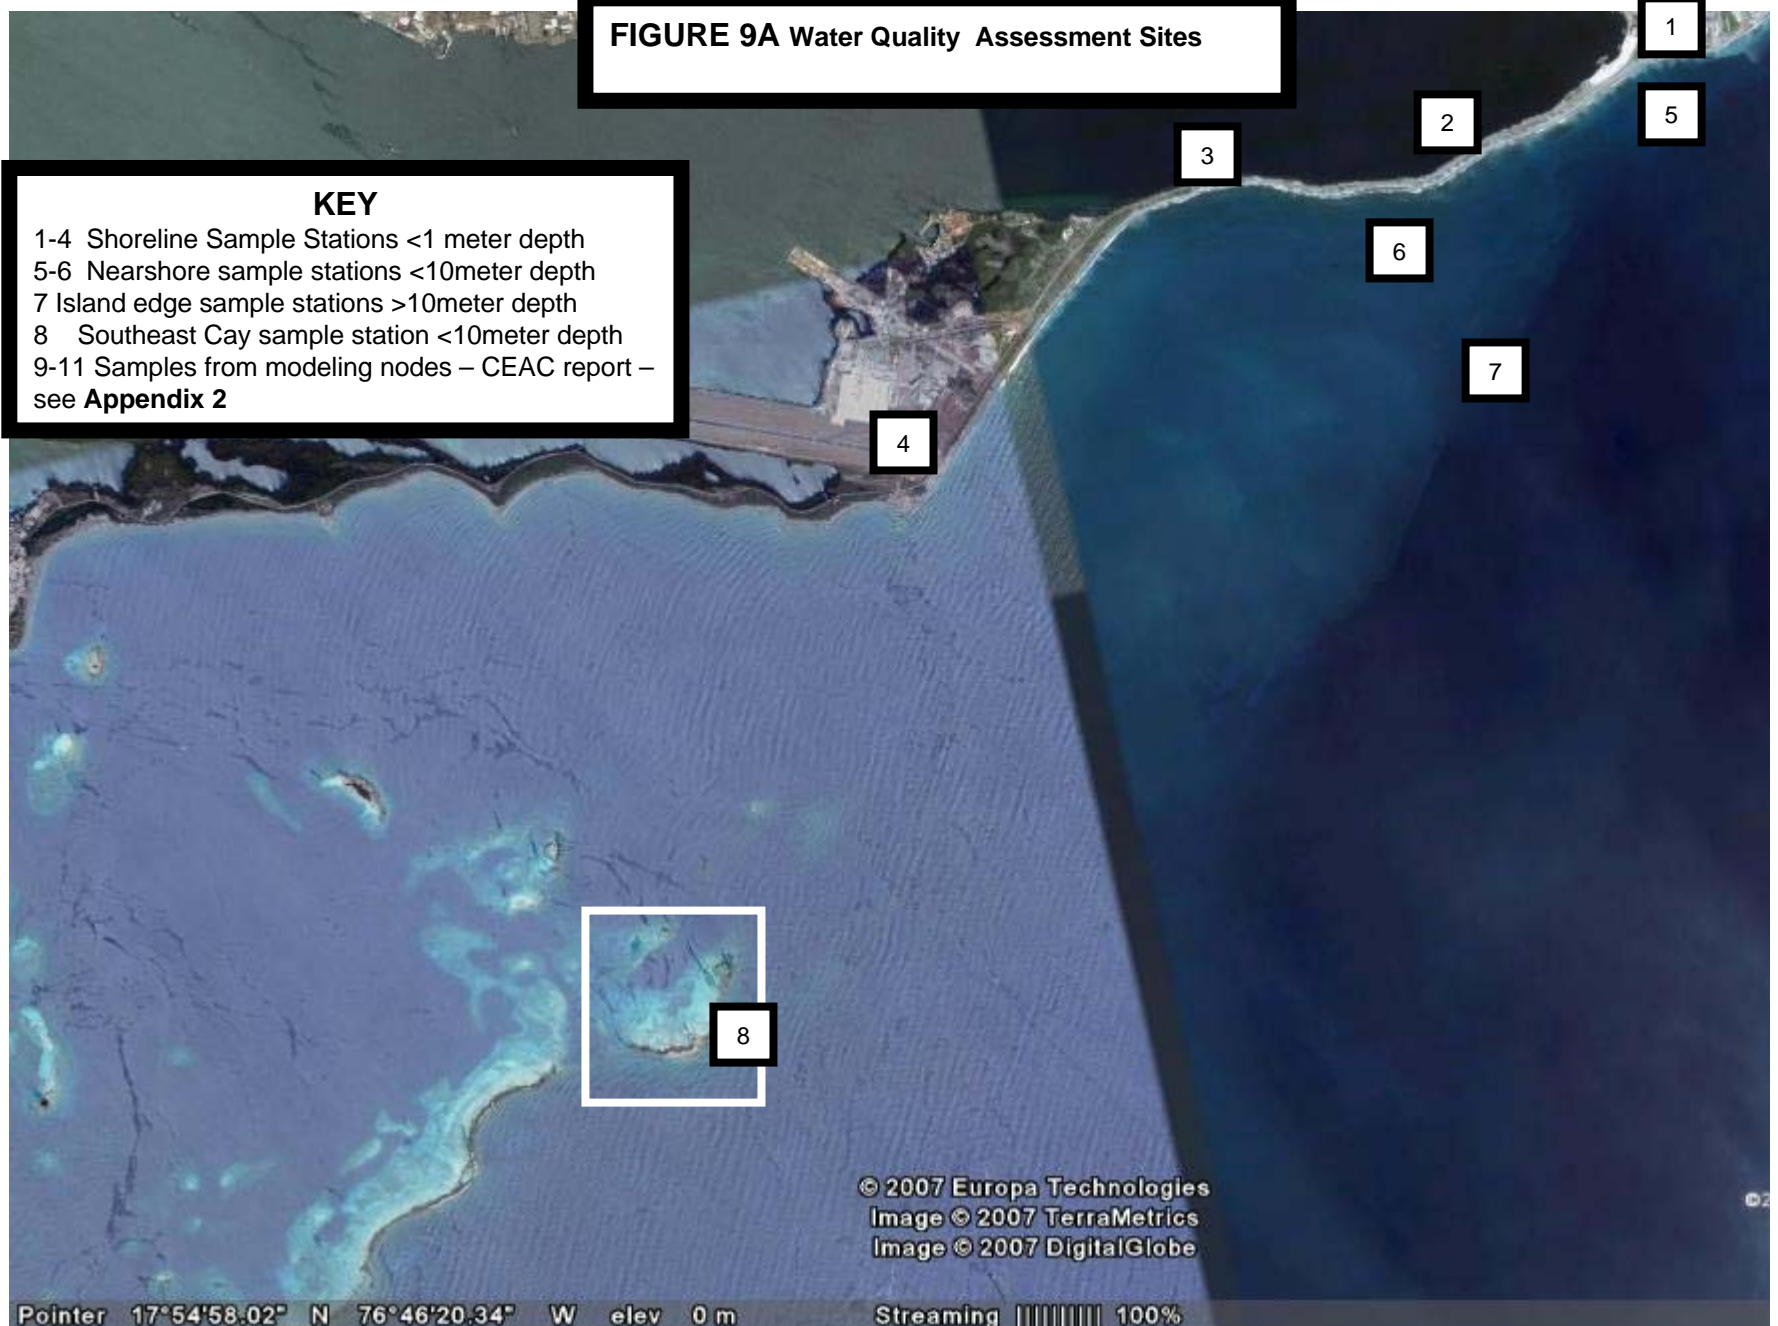
FIGURE 9A Water Quality Assessment Sites

- 1-4 Shoreline Sample Stations <1 meter depth
- 5-6 Nearshore sample stations <10meter depth
- 7 Island edge sample stations >10meter depth
- 8 Southeast Cay sample station <10meter depth
- 9-11 Samples from modeling nodes – CEAC report – see **Appendix 2**

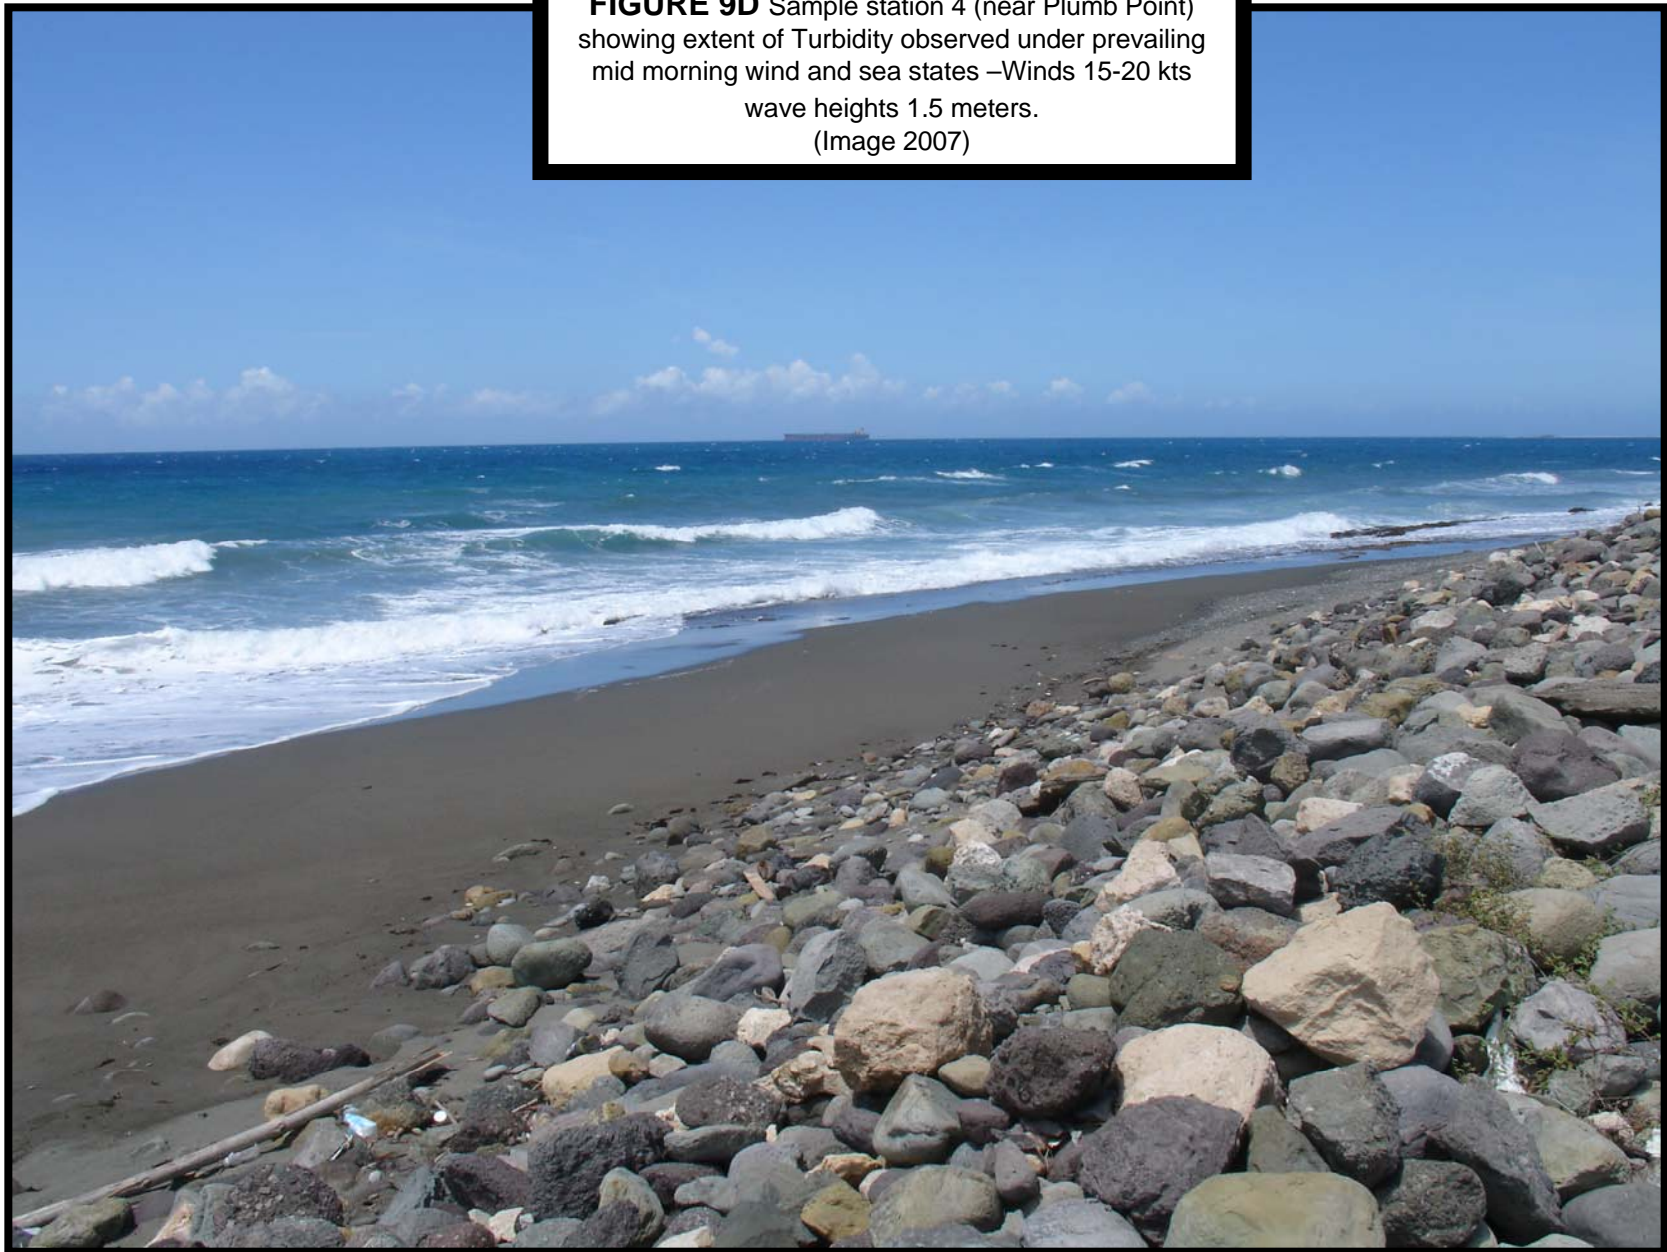
FIGURE 9D Sample station 4 (near Plumb Point)
showing extent of Turbidity observed under prevailing
mid morning wind and sea states –Winds 15-20 kts
wave heights 1.5 meters.
(Image 2007)

Initial Secchi disc sampling was done during February of 2007, during a period of very calm seas. Water sampling for total suspended solids was done in June of 2007, under sea conditions that could be regarded as being “normal” for the area, as illustrated at sample stations 1, 3 and 4 (see **Figures 9B-D –Appendix 1**). These

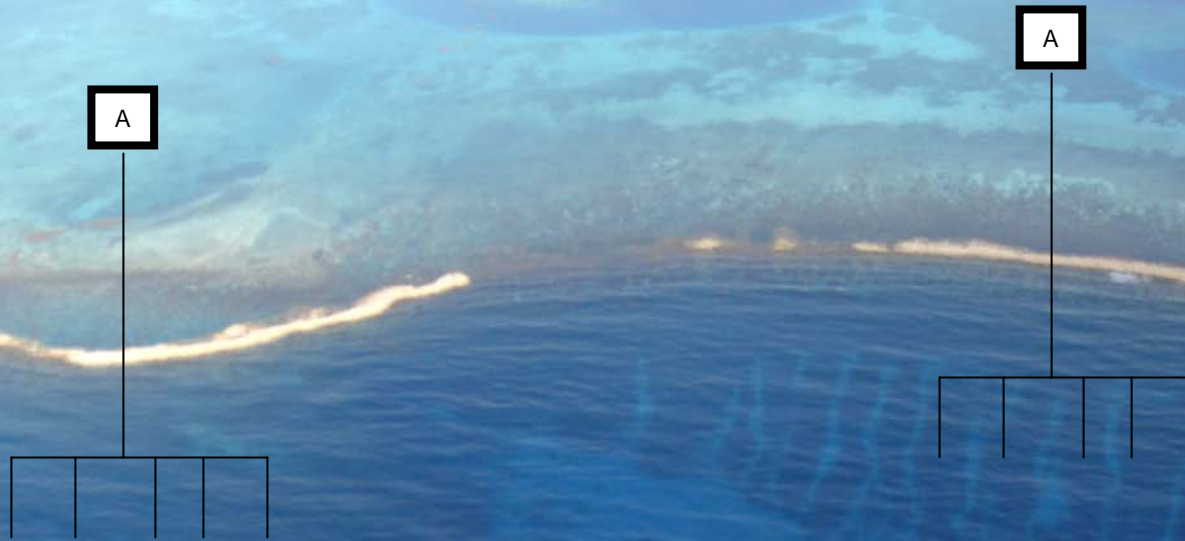
FIGURE 11B Close-up Aerial Illustration of Spur and Groove formations (A) Characteristic of Shallow and Deep Reef areas Adjoining Project Area at Palisadoes (taken of reef areas at Barrier Reef South West of SE Cay

As indicated previously, both deep and shallow water reefs had spur and groove formations. These spurs and grooves are of low depth and relief and exhibit low rugosity³⁵. The surface of the spurs was dominated by growths of fleshy green and brown algae with occasional heads of boulder corals being observed. **Figure 12A – Appendix 1** outlines examples of the corals observed at both deep and shallow coral sites. These are listed as follows:

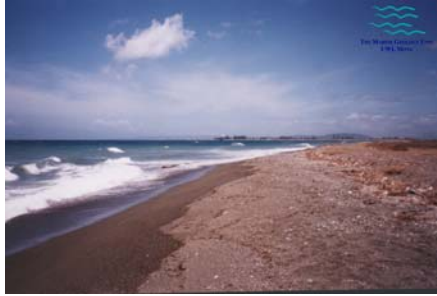
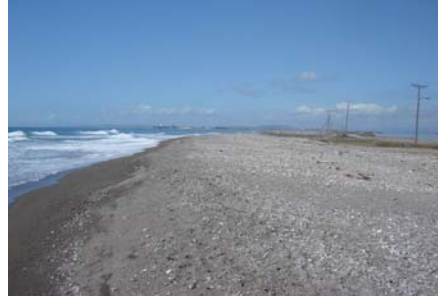
Picture 1. (Left). After Hurricane Ivan. (Provided by Professor Ted Robinson). Notice the rapid conformation of the berm and the beach profile after the pass of Hurricane Ivan.
Picture 2. (Right). December 2006. Notice that the characteristics of the profile are maintained.

This beach profile behaviour has been maintained even after the pass of Hurricane Ivan in 2004. As it may be appreciated in Picture 1 taken shortly after the pass of Hurricane Ivan and Picture 2, taken during the field works in December 2006, for most of the eastern part of Palisadoes the beach profile recovered rapidly adopting a typical conformation of cumulative coast, with a wide and well-defined berm with diurnal variation like that explained by Hendry, (1979).

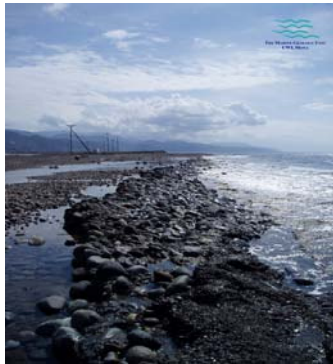
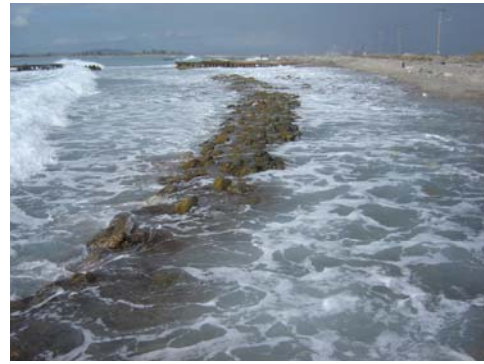
Picture 3. (Left). After Hurricane Ivan. (Provided by Professor Ted Robinson). Widening of the beachrock outcrop after the pass of Ivan.
Picture 4. (Right). December 2006. Notice that the beachrock outcrop is maintained.

However, pictures 3 and 4 corresponding to the most critical sector in Palisadoes, show how Hurricane Ivan caused the widening of beachrock and the recovery of the beach profile did not reach this area in the same way, thus confirming that the volume of material required for the profile restoration does not exist in the submarine slope, and no new inputs are reaching the sector through the longshore transport.

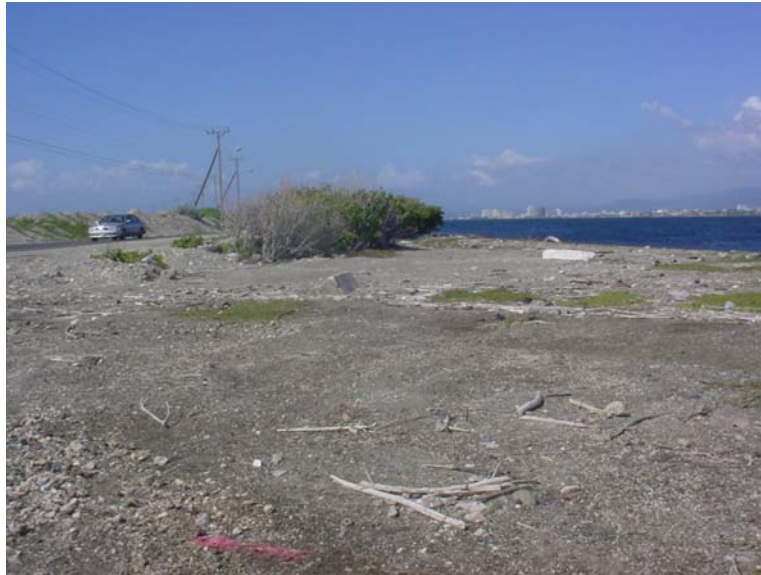
Picture 9. Transfer of sand from the dune toward the inner part of Kingston Harbour produced by Hurricane Ivan in 2004.

First of all, it should be highlighted that the erosive process in Palisadoes most critical sector is mainly characterized by the transfer of sand from the dune toward the inner part of Kingston Harbour, due to hurricane-caused surge and wave. This process became evident with the occurrence of Hurricane Ivan in 2004. (Picture 9).

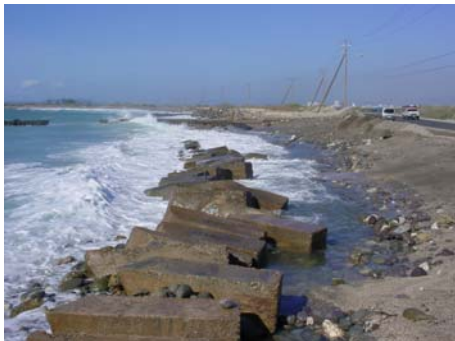
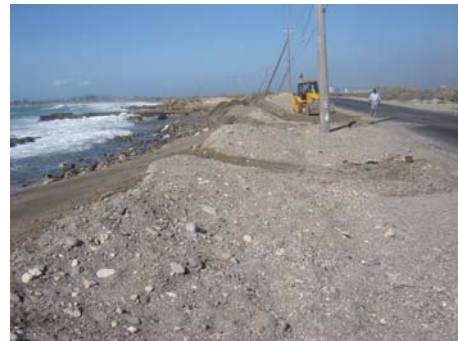
Pictures 10 and 11. The more critical sector of Palisadoes.

As it is appreciated in pictures 10 and 11, the work sector comprises a tract of 300 m where the proximity of the road to the coastline does not ensure that the mere dune reconstruction protects the road in case of the occurrence of a hurricane. For this sector it has also been conceived the construction of a quarrystone revetment.

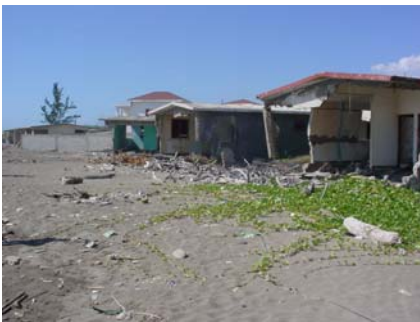
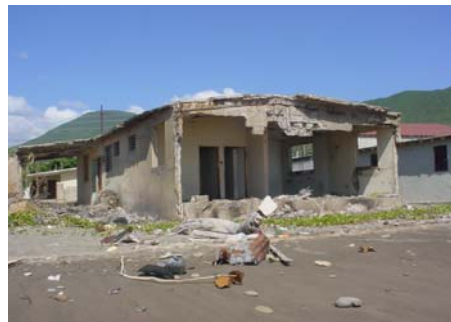
Pictures 14 and 15. Caribbean Terrace houses damaged by Hurricane Ivan in 2004.

As part of the study carried out, it was included the coastal front of Caribbean Terrace, where Hurricane Ivan caused the almost total destruction of some 17 houses located on the first coast line. As it is appreciated in pictures 14 and 15, the ruins of the impacted facilities still remain there.

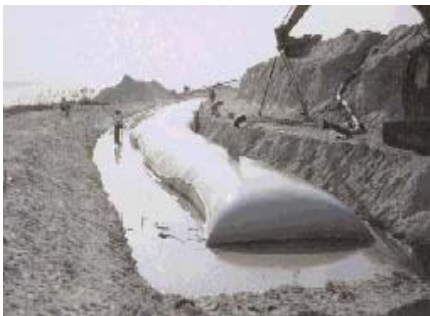
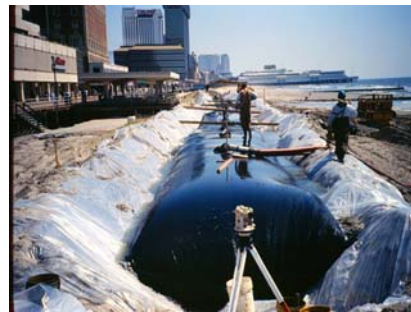
Pictures 21 and 22. Example of geotube structures to protect the coast.

At first, it was conceived to build a structure using geotubes, like those shown in Pictures 21 and 22. But, taking into account the low availability of filling material and its unsuitable quality, as well as the depth of over 1 m at the site where the structure should be located, it was decided to design the revetment using quarystone.

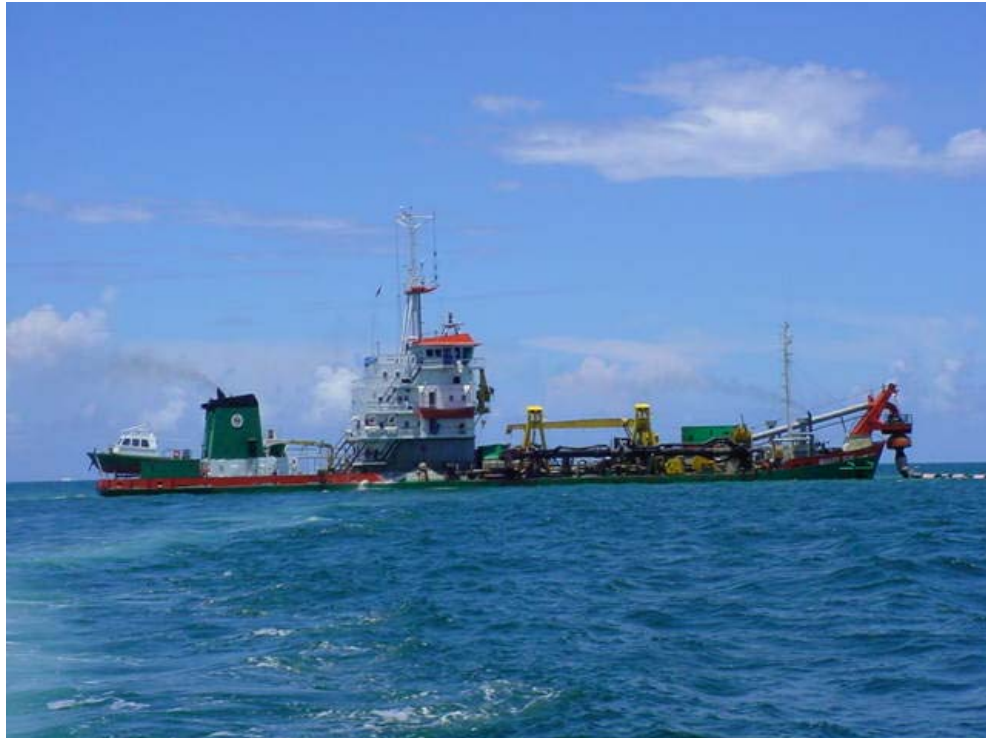
Picture 23. Quality Star trailing suction hopper dredger, belonging to ASTIMAR S. A. Company, coupled by its prow to a floating pipeline to start the sand discharge. Hopper capacity 2 400 m³.

The execution of this project has been conceived for a medium size dredger, with hopper capacity between 2 000 m³ and 3 000 m³, and draught between 5 m and 6 m, regularly available in the dredger market (Picture 23).

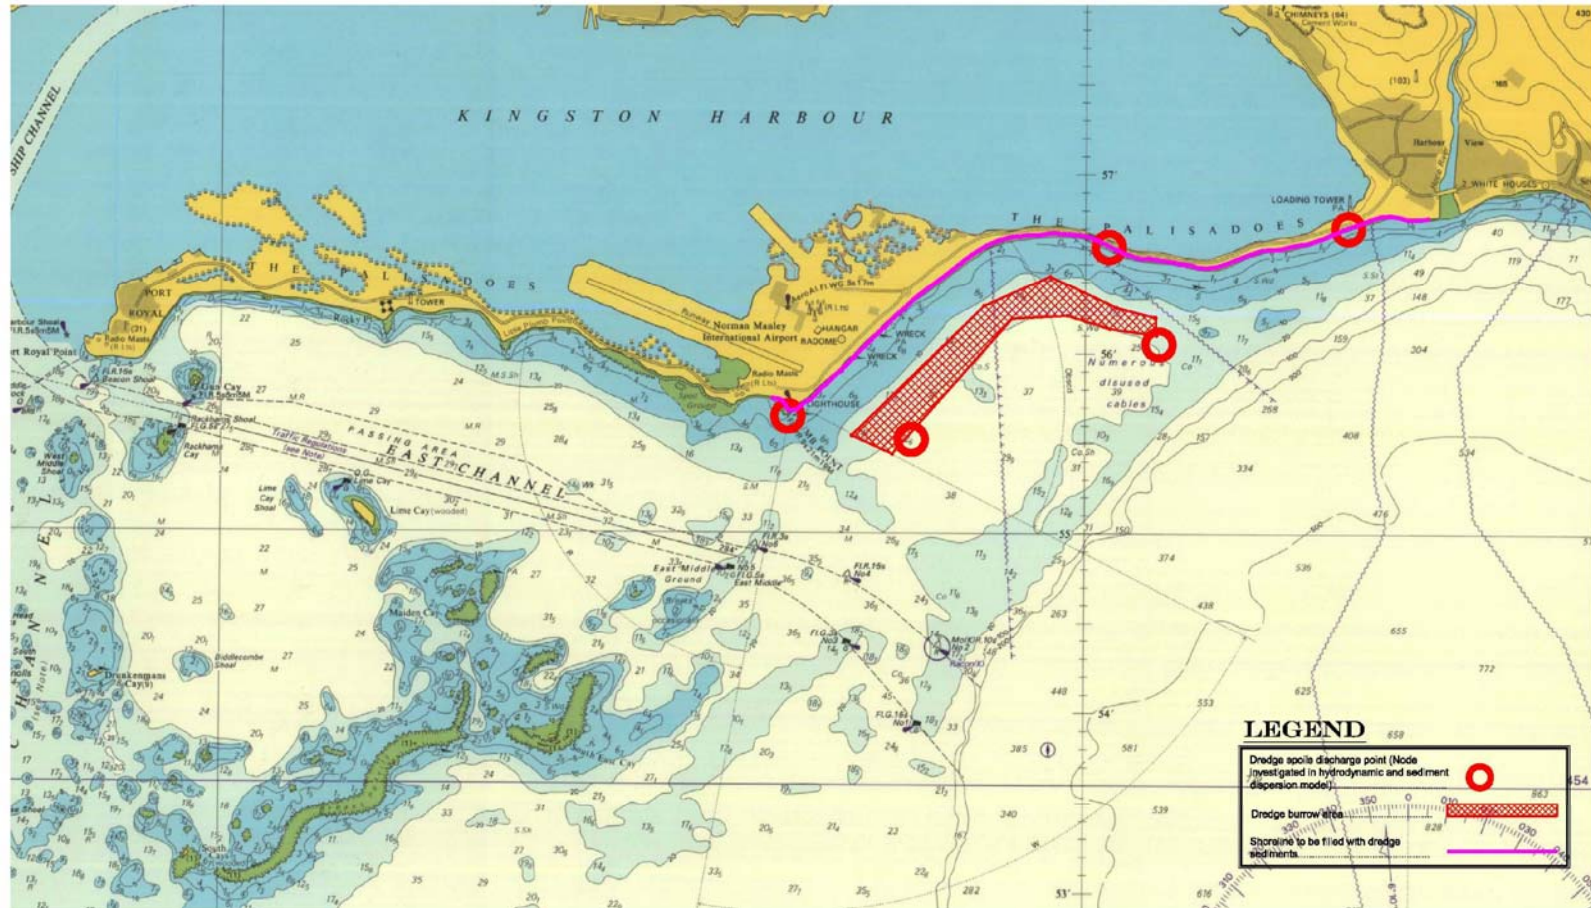
Figure 2.2 – Bathymetric Map of Area showing nodes (RED DONUTS) for sedimentation plume modeling
